Pipistrel's Official Statement

Related to accident of Virus SW 100, I-B939 on 3 October 2015 at Bovec, Slovenia

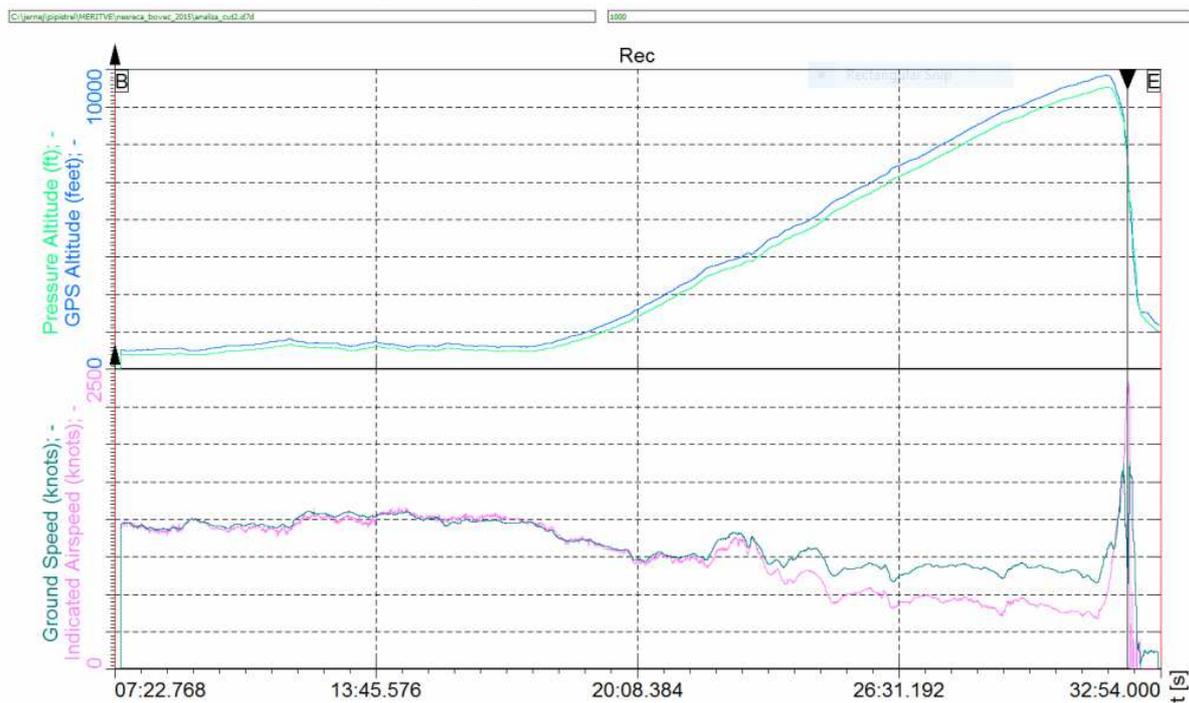
The aircraft Virus SW 100 I-B939, occupied by a crew of 2, departed from Caorle, Italy and flew in a north-easterly course according to Visual Flight Rules (VFR). After flying at low level the aircraft initiated a climb to from 300 m (1000 ft) AGL.

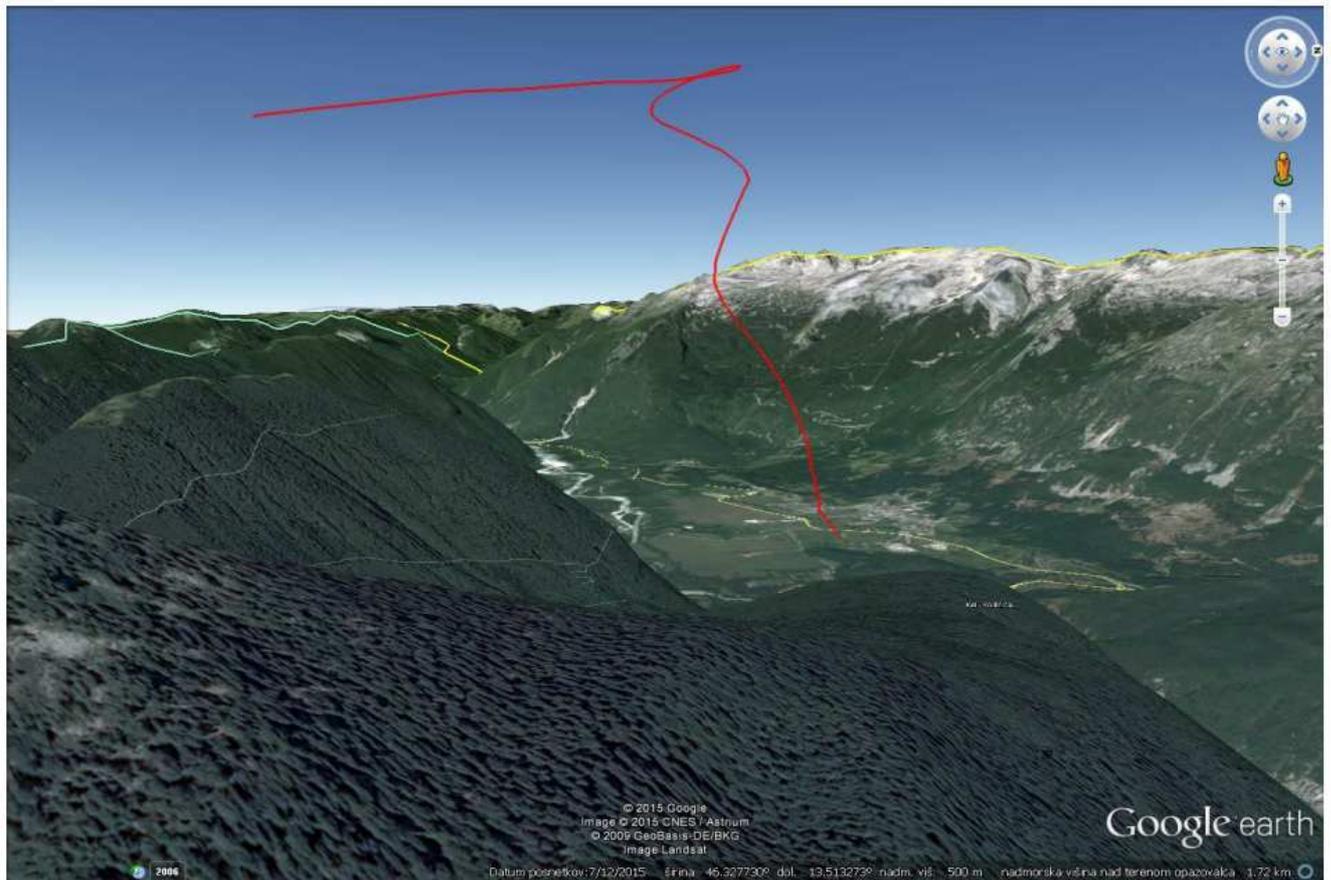
At the time of flight, the cloud base was overcast between (1000-1300 m) 3000-4000 ft. In Instrumental Meteorological Conditions (IMC) and reaching approximately (3000 m) 9800 ft inside clouds where the temperature was 2 degrees Celsius, the aircraft stalled, departed controlled flight and entered a steep dive.

The aircraft surpassed its maximum permitted operating speed of 163 kts (302 km/h) and reached 240 kts (445 km/h) indicated airspeed when the crew began to recover the extreme nose-down inverted attitude. During this action, the aircraft decelerated to 220 kts (405 km/h) and reached 6 G of load. Next, the load suddenly increased to over 10 G (flight data recorder senses a maximum of 10 G load, then becomes saturated) – at this conditions, 220 kts (405 km/h) and over 10 G, load the aircraft wings structures separated from the airframe. This was followed by an inverted steep dive with 105-120 m/s (21-24.000 fpm) sink rate. The crew activated the ballistic rescue system on board the aircraft a mere 515 m (1700 ft) above the ground when the speed of the aircraft was over 450 km/h (245 kts) flying at an almost vertical flight path referenced to the ground . The sink rate was stabilized as the parachute was fully opened approximately 150 m (500 ft) above the ground. Judging by the above facts, the crew activated the parachute rescue system 3-4 seconds before imminent impact with the ground and 1-2 seconds before it would be too late for the parachute rescue system to be deployed successfully.

The accident occurred after the aircraft, which is not approved for flying in Instrumental Flight Rules and/or Instrumental Meteorological Conditions, stalled inside clouds, departed controlled flight, surpassed the maximum permitted operating speed by a factor of 1.47 and the permitted G-load by a factor of more than 2.5. The parachute rescue system, which is designed to be used up to speed of 315 km/h (170 kts) was activated successfully at over 450 km/h (240 kts) after major airframe components ultimately separated from the vehicle; a testament to aircraft and systems' design.
